THE OFFICIAL ELECTRONIC
PUBLICATION OF THE SHIELDS
CLASS SAILING ASSOCIATION

SPRING
2020

Becoming Fluent in Shields Restoration

Acquiring Fluent, Shields 124

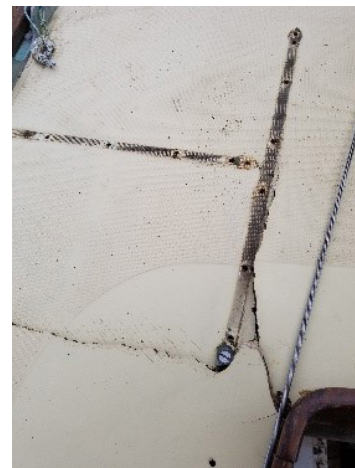
Based on our assessment, the boat had three main structural problems and one overall problem. They were: 1) The boat is a Chris Craft built Shields, hull number 124, and the forward deck had delaminated. It appears that when someone winched in the port side jib sheet, it ripped the track out of the deck and split the deck. 2) The boat had a battery-operated bilge pump and the boat had a history of leaking. The water was making its way through the keel into the bilge. 3) The mast step on some of the Chris Craft boats were made of plywood and this one was rotten. 4) This boat had raced in Michigan and Newport, but that was years ago. Recently, it was used by its owner as a cruising boat, so much of its hardware and lines were out of date and needed to be replaced. [Right: Picture 1](#)

As I mentioned above, the fiberglass on the deck was significantly cracked and ripped at the aft end of the port side jib track. (See picture 1) When you examined it under the deck, the bottom skin was also ripped, so much of the structural integrity was lost. Chris Craft built Shields are different from Cape Cod Shipbuilding built Shields in a couple ways regarding the deck. First, and most importantly, the core material of the deck is plywood, versus fiberglass. The obvious problem that this presents is that over time, water can

make it's way into the core and rot the wood. This was the cause of Fluent's deck failure. Secondly, the deck is thinner than the decks on Cape Cod Shipbuilding built boats. I am not certain of the reasons, but I suspect that Chris Craft was trying to cut costs in making these boats and possibly lighten the weight of the deck.

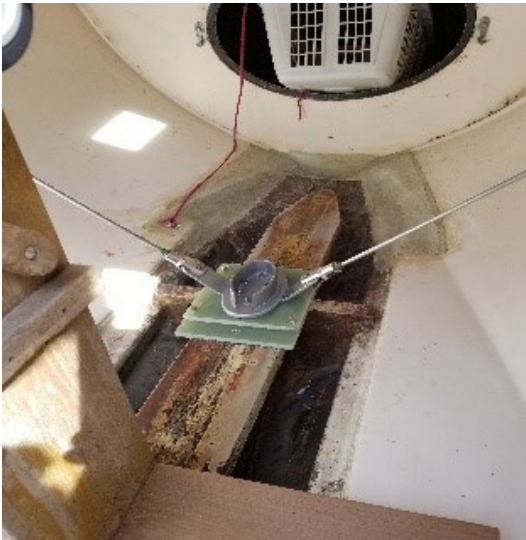
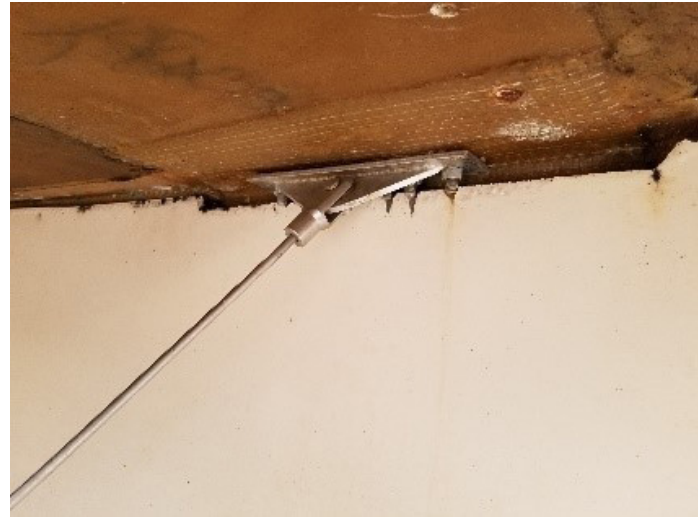
Above Left: Picture 2 Above Right: Picture 3

in the upper and lower layers of fiberglass, and had solid core material, it should be strong. The strength of the chainplates comes from their attachment to the hull, which in this case was solid. This boat also has a tie-rod system under the deck, with tie-rods connecting to the mast-step. (See pictures 2 & 3) This system also provides further support and strength.

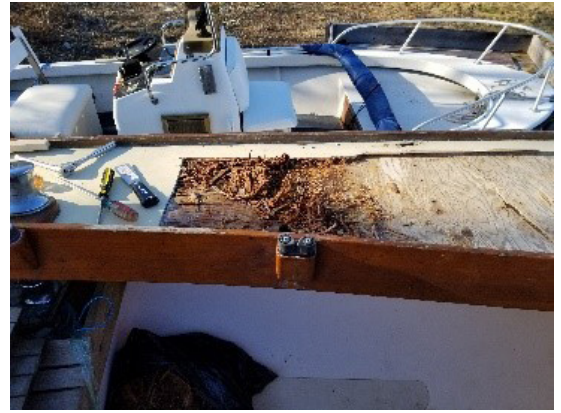
Below Right:
Picture 8

Repairing the bottom skin of fiberglass – As I mentioned before, when the deck failed, the jib track ripped out of the deck, tearing the upper and lower skin of the deck. Before we started to replace the core material, we needed to repair the lower fiberglass skin of

the deck. To do this, we laid in new sheets of bi-axial cloth glass over and under the torn skin. (See picture 8) To make sure that the shape of the bottom layer was correct, we built prop legs from 2x2s and 2x4s and supported the bottom layer with these legs until the fiberglass repairs had cured.

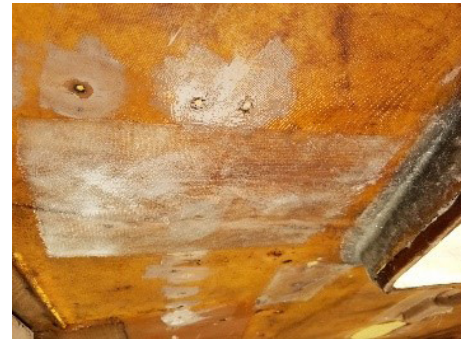
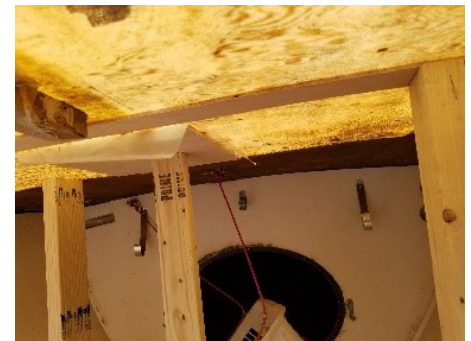
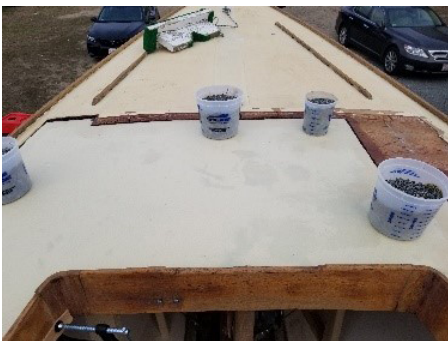
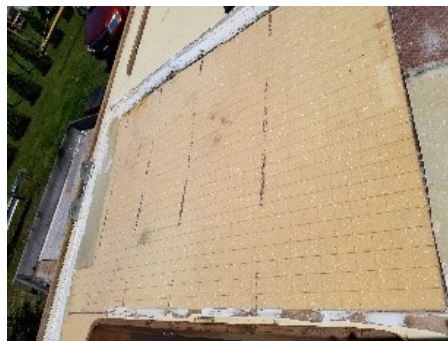
Just Above: Picture 9
Far Left: Picture 10 then Picture 11
bi-axial glass, lots of poly resin,
and the new Corecell material,
we applied buckets of weights
to ensure that the Corecell
would bend into the appropriate
arch shape. (See picture 10) When
we came back to the boat the
following weekend, we were
surprised and highly disappointed
that the deck was “crunchy” and
had no

strength. It appears that the Corecell was too rigid for the job and wouldn't conform enough to the arch shape. This required a miserable job of cutting out all the new core material and resin. We actually had to chisel a lot of it out and my shoulders complained for a couple days. After re-thinking the whole process we came up with a new solution with the aid of Jamestown Distributors. Since we believed the primary cause of the first repair's failure was Corecell's rigidity and inability to mold to the bottom deck skin, we selected a different core material called Divynycell. This looks like bathroom tiles on a cloth sheet. It easily molded to the shape of the bottom layer of fiberglass. (See Picture 11)

Selecting and installing new core material – With the bottom skin now in one piece, we could start to replace the core material. But before we did this, we built a network of prop legs out of 2x2s and 2x4s to hold the bottom layer of fiberglass in place. (See picture 9) Again, the strength of the deck is derived from the arch shaped structure and the relative distance between the upper and lower fiberglass deck skin. When selecting the core material, I wanted to make sure that nobody would have to do this job again, so I was leaning heavily on using manmade materials vs plywood. I looked through the class rules and consulted people from the class association and found that there is no restriction on what I could use. I then consulted with Jamestown Distributors, a great source for boat making and repairing. We discussed and selected Corecell, bi-axial glass, and polyester resin. After working a long day of laying in several layers of

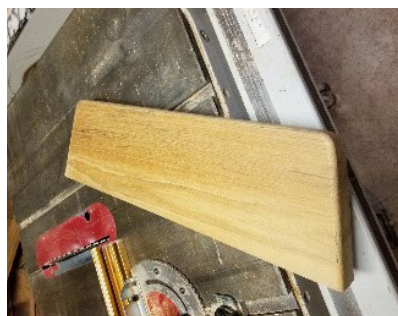
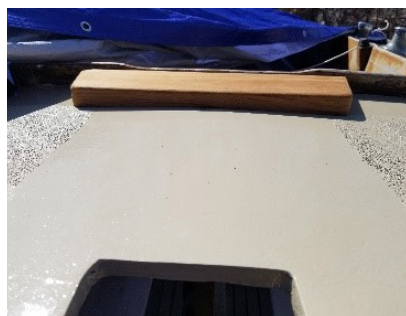
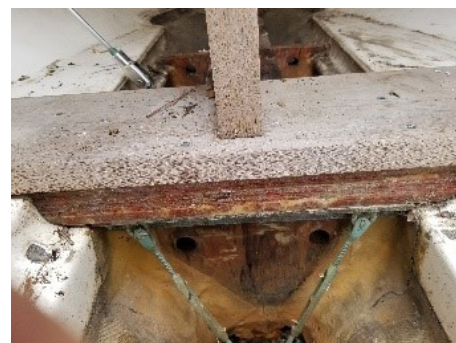
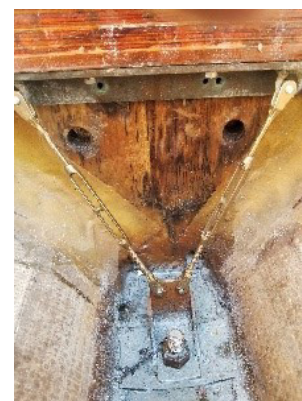
[Above Left to Right: Pictures 15, 16 and 17](#) [Right: Picture 18](#)

There are a couple of other things that can be done to strengthen the deck. 1) Ensure the deck is securely attached to the kingpost. We had a couple of problems that needed attention here. Fluent didn't have a traditional console that is seen on many Shields, so we needed to buy some teak and make one. (See picture 15) The most challenging part of this process was to shape the bottom of the console to match the arched shape of the deck. For that we scribed and cut a template out of cardboard and traced it onto the new teak console. Then, using a belt sander, we carefully shaped the teak until it sat firmly on the deck. (See picture 16) You need to be very careful because, as we learned, it is very easy to take too much wood off and teak is not cheap. On some of the Chris Craft Shields, there is a large piece of teak, running from port to starboard that the kingpost sits on. On Fluent, this piece of teak was rotten and needed to be replaced.

This piece of teak screws through the fiberglass floor into a metal structure, that is connected, via turnbuckles to a keel bolt. (See pictures 17 & 18) When the console is screwed through the deck into the kingpost, and the kingpost is secured to this teak base that is secured to the keel bolt, it provides significant downward pressure on the deck and resists bowing of the deck when the rig is under load. 2) Supporting the deck. We considered adding wooden support beams under the deck to provide additional strength. There are a number of Shields who have done this and it works quite well to strengthen the deck. After we finished the core replacement, we felt that the deck was strong enough without the support beams and in the interest of getting the boat in the water, we delayed this project. We may add them later, if needed.

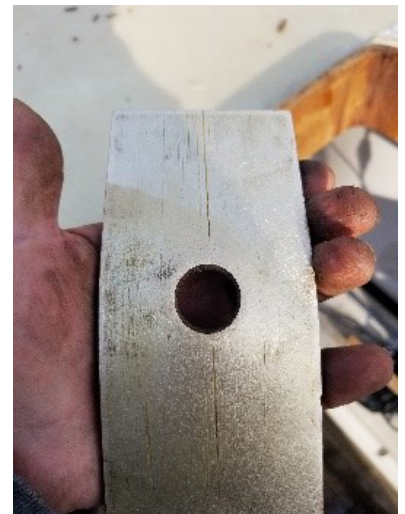
We were rather fortunate that the boat had been into Cape Cod Shipbuilding before we bought it and they had identified some leaks from the deadwood into the bilge, but the owner didn't authorize the work. These areas of leaks were around the forward-most floorboard, the mid-ship floorboard support, and the keel bolts. The floorboard leaks were simple repairs, but the keel bolts needed a lot more effort. Two of the keel bolts had the lifting eyes frozen on and no matter what we tried, we couldn't remove them. Fortunately for us, each of the keel bolts were also too long. So long that we couldn't get a socket on them. This was very helpful, so what we did was use a cutting wheel on a grinder and shortened each of the keel bolts, just enough to get the socket on them. On the two bolts that had the lifting eyes, we cut just under the lifting eyes and still have enough room to attach new eyes if needed. [Right: Picture 23](#)

we went around all the deadwood seams, hull to deadwood, and deadwood to lead. These seams were leaking, letting water into the deadwood. We suddenly heard a loud hissing sound at the back of the keel, about 6-8" up from the shoe, in front of the rudder. The seam at the back end of the keel was leaking badly.

Keel bolt leaks - One at a time, we removed the nut on the keel bolt, pried up the bronze plate, and using a grinder, smoothed out the bottom of the bilge under the plate. Using a wire brush on a drill, we cleaned the bronze plate, making it smooth and debris free. (See picture 23) We then cut three layers of bi-axial fiberglass cloth in the shape of the bronze plate, with a hole in the middle for the keel bolt. Using West System epoxy, we thoroughly wet the area of bilge under the plate and each of the 3 layers of fiberglass cloth. We then put the plate on and torqued the keel bolts at their specified level, 140 psi. Note, when removing the keel nuts, two broke. They are rather large bronze nuts and we found one at Cape Cod Shipbuilding and the other online through McMaster-Carr. Testing the keel for leaks - With the help of Ken Deyett, we applied about 2-3 psi of pressure in the drain plug of the keel. Then using soapy water

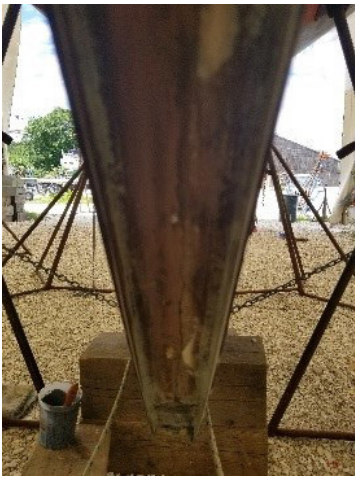
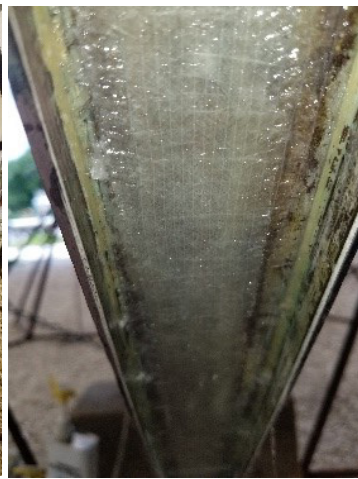
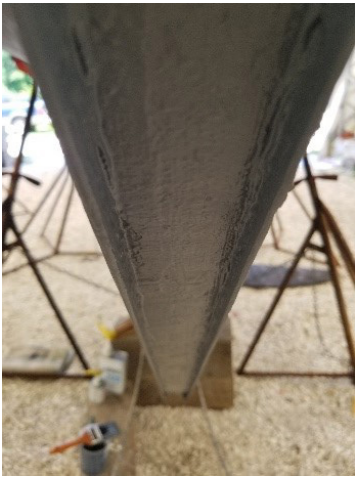
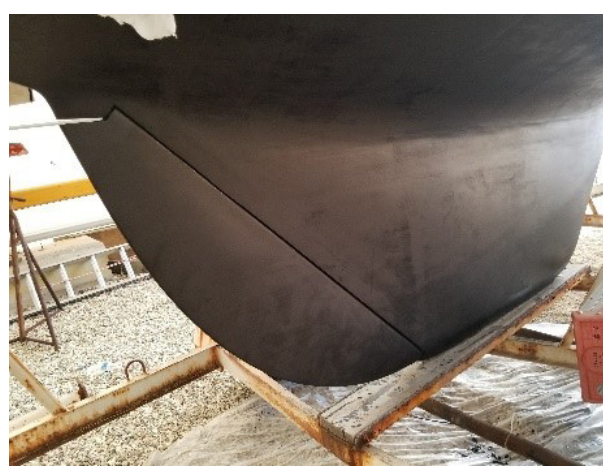
[Upper Left Clockwise: Pictures 31-34](#)
[Below: Picture 35](#)

(See picture 31) Our rear seam was very smooth and the crack was easily visible. We sanded the back of the keel, between the rudder strips and then layered 2 layers of bi-axial cloth with west system resin down the whole back seam of the keel. (See picture 32) Be careful not to make the repair too thick because there isn't a lot of clearance for the rudder to move. After the fiberglass is cured, we applied 3 coats of Petit Barrier Coat to seal under the seam (see picture 33) We then put the rudder back on and faired the shoe and fairing strips. After it was all sanded, we painted the bottom of the boat. (See picture 34)

Repairing the leaks at the back of the keel – This wasn't a hard job to do, but getting to the area leaking it is very hard. To access the leak area, you need to remove the rudder, which is difficult. We first used a grinder to fully expose the bronze shoe that connects the bottom of the rudder to the keel. (See picture 30) Sometimes you may need to remove the fairing strips, but in our case, they were fiberglass, and in great shape, so we elected to leave them on. If you try to take them off, you may break them and need to buy new ones. Then you need to lift the boat at least 18", allowing enough room for the rudder to slide downward. It is important to note that the rudder needs to slide down perfectly straight so you don't break the rudder tube that surrounds the rudder shaft. If this breaks, it will cause a leak. Then you remove the tiller and the rudder nut.

We put a pair of vice grips on the rudder shaft so the rudder wouldn't drop prematurely. Then have one or two guys hold the rudder while another person removes the screws from the bronze rudder shoe. It is a good idea to loosen these first. We had one that was frozen and required more work. Once the screws are loose, take a piece of wood and gentle tap on the top of the rudder shaft and the rudder should drop. Again, make sure you have people helping guide it straight down. Once it is out, you have an easy view of the rear keel seam.
