THE OFFICIAL ELECTRONIC
PUBLICATION OF THE SHIELDS
CLASS SAILING ASSOCIATION

SPRING
2020

Becoming Fluent in Shields Restoration

Acquiring Fluent, Shields 124

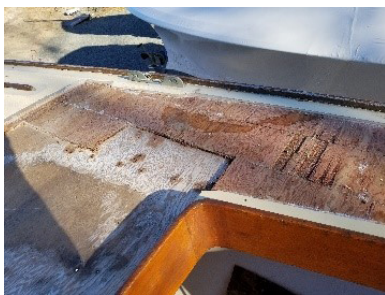
Above Left: Picture 4 Below Left: Picture 5

Cutting away the old material – Based on our plan, we started cutting the upper layer of the fiberglass deck with a grinder and removing sections until we got back to solid core material. It is important to go easy here as we wanted to only remove as much deck as needed until we had solid, dry core material. We also didn't want to cut the bottom layer of the deck fiberglass, as that would weaken the structure. In Fluent's case, we had to remove a significant portion of the deck just ahead of the cockpit, from chainplate to chainplate, from the handrails to the jib winches. Once we cut and removed the upper layer of fiberglass, we removed all rotten plywood core material. (See pictures 4, 5, 6, & 7) This was tough work, we used chisels and a grinder, again being careful not to damage the bottom layer of fiberglass.

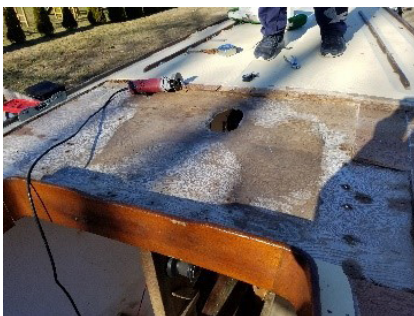
Repairing the bottom skin of fiberglass – As I mentioned before, when the deck failed, the jib track ripped out of the deck, tearing the upper and lower skin of the deck. Before we started to replace the core material, we needed to repair the lower fiberglass skin of
